# The Report Card

Little Topashaw Creek Watershed

# Management practices for channel erosion and habitat rehabilitation

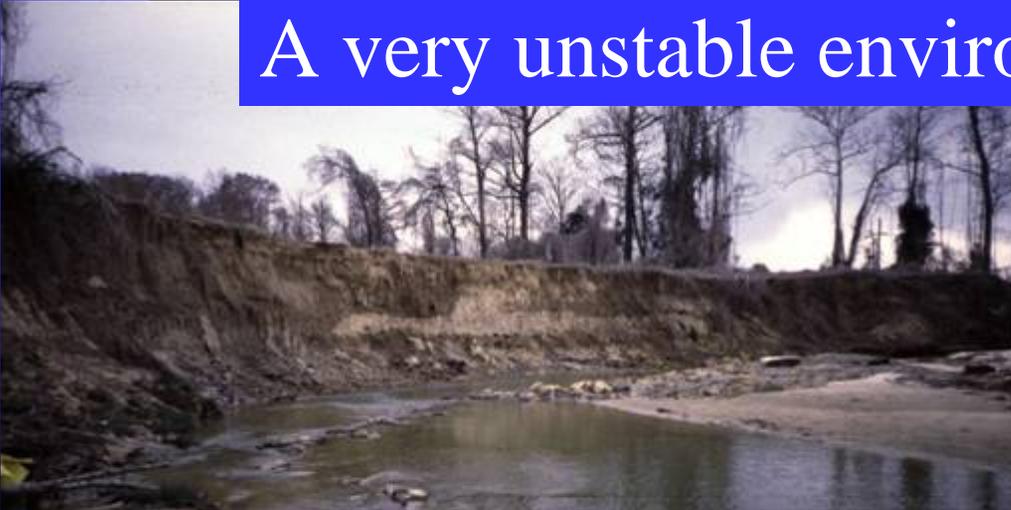
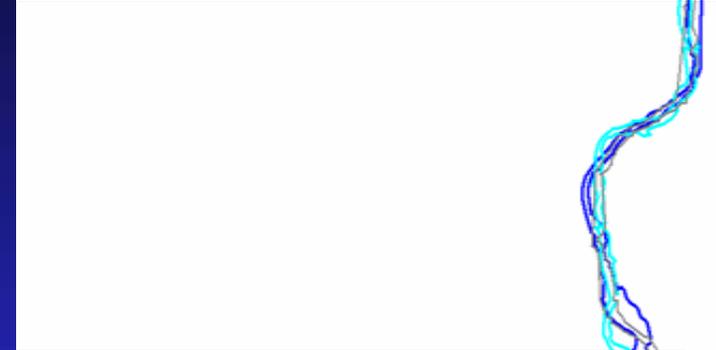
## A very unstable environment

Sediment yield dominated (~85% of total) by products of channel bed and bank erosion.

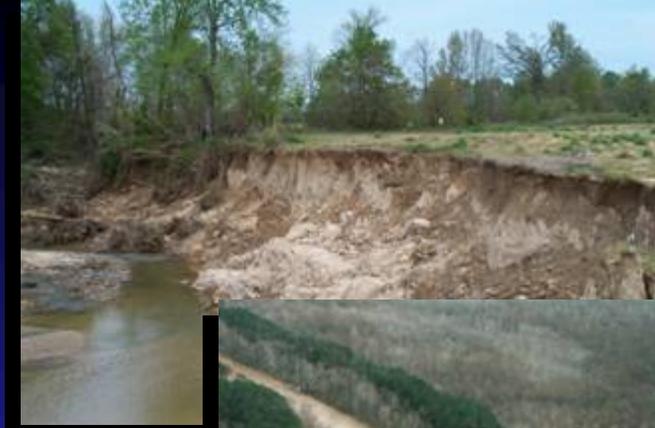
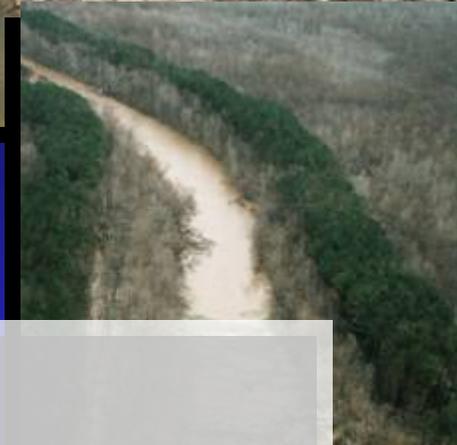
# Geomorphology

- Watershed characterization
- Knickpoint migration rates  
(up to 12 m/yr)

- Cohesive bed and bank erosion

- Real-time process—No Grade  
downstream 3/4 aggrading,  
upstream 1/4 degrading

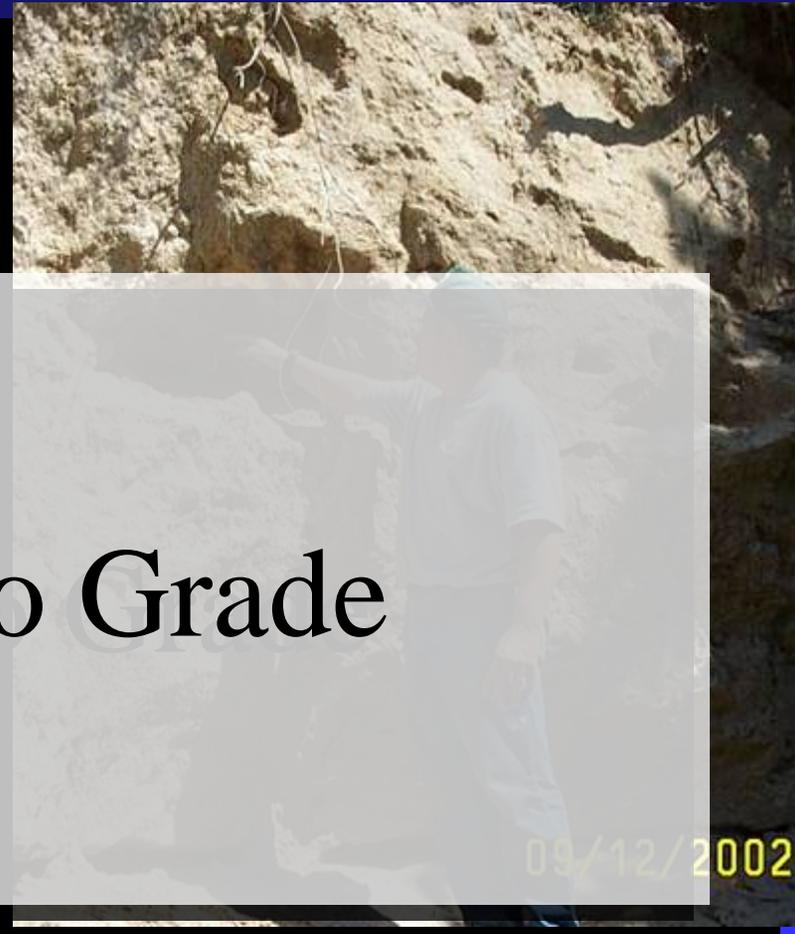
# Subsurface erosion

- Seepage flow and sediment concentrations were measured *in situ* at eight locations

- Sediment concentrations as high as  $660 \text{ g L}^{-1}$

- Foundation for laboratory lysimeter

- Results compared to ARS Bank Stability Model simulations

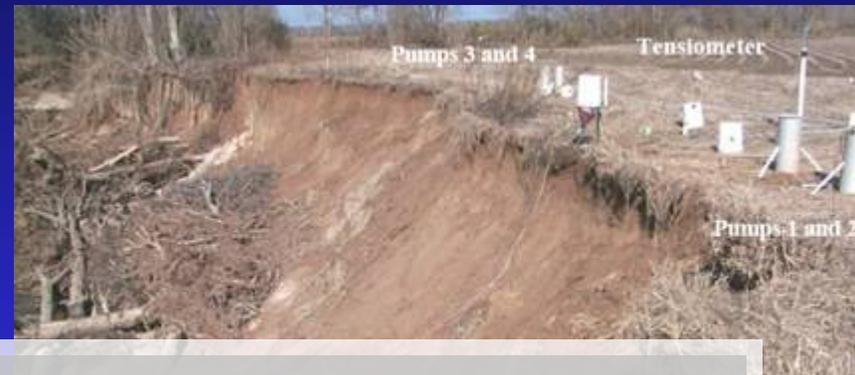
# Bank stabilization using pumps

- Reduced pore water pressure
- Retreat rate lowered by factor of 2 over

two-year period

■ No mass failures

■ Safety factor increased

## Effectiveness of pumps—B-

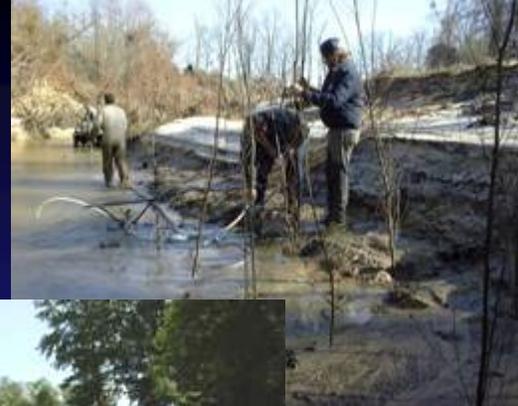
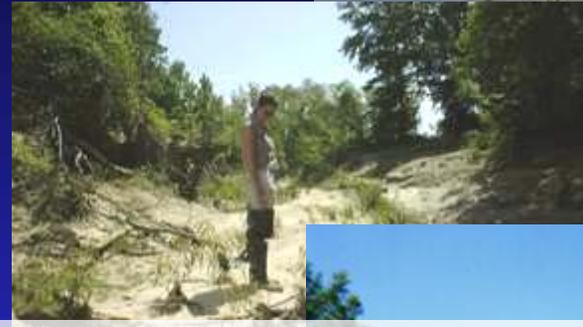
# Willow cuttings for bank stabilization

- 4000 willow cuttings planted on bars and banks

- Performance of presoaked and unsoaked cuttings showed positive effects of soaking on survival and growth

- **Effectiveness of willows—F**  
governed by soil texture and depth to water table

- Three-year survival < 10%!

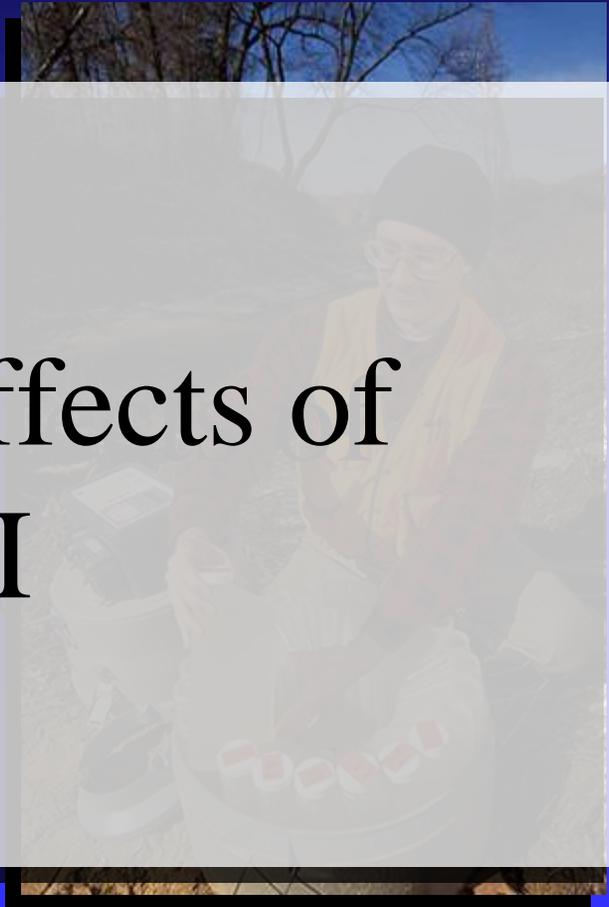
## Water quality effects of project--I

- Many pesticides were detected in runoff events following applications
- Pesticide detections and concentrations correlated with runoff events following applications
- Analysis of effects of rehabilitation still pending

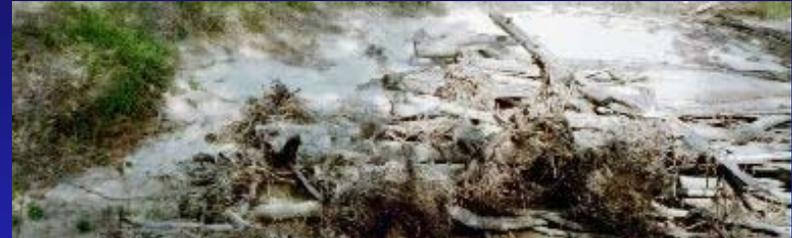
Rhodamine Dye Concentration vs Time after

- Mean velocity reduced 40 % relative to downstream

untreated reach eight months after construction

Overall retention 100%

## Effects of project on retention--C

large wood ( $F_{med}$ )

Hyporheic storage less than 0.5% of total storage

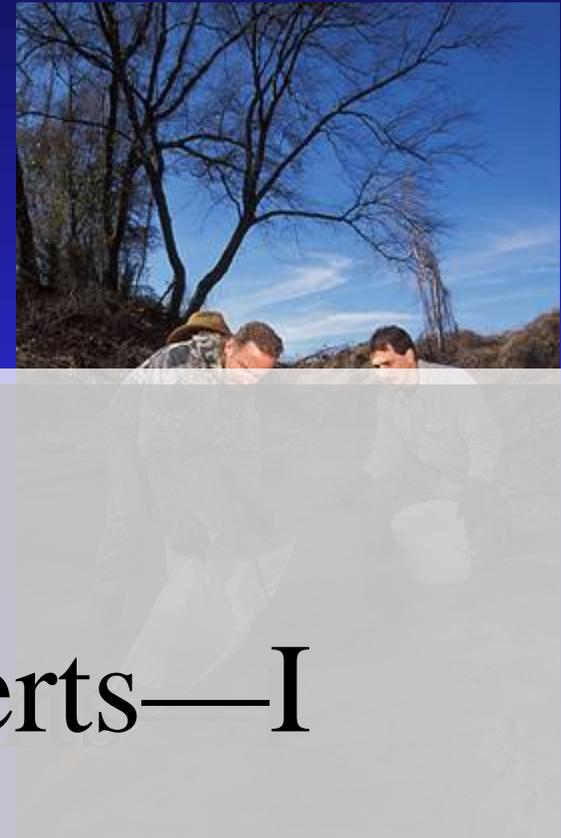
**Effects on inverts—I**

- Large increases in abundance of “desirable” types
- Increased biodiversity

- These increases occurred in treated and untreated reaches
- Major shifts in community composition in a reach
- Final analysis still pending

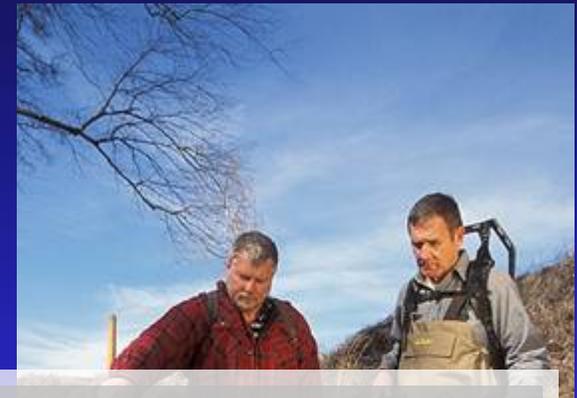
## Effects on fish—C

- Field data and numerical modeling indicated initial improvements in habitat quality due to LW addition
- Longer-term habitat effects were modest—mostly just an increase in LW density
- Number of fish species doubled
- Species composition shifted to be more typical of less-degraded reference site
- Some similar changes occurred in the untreated reach downstream
